THE GAMGRAM

No. 43

IT IS EASY TO BLAME THE FILTER

MAY 1995

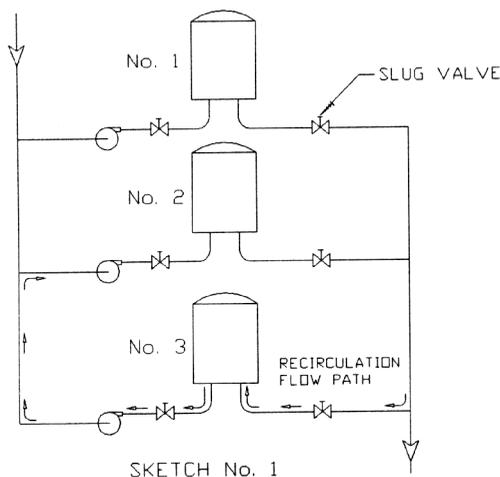
After a study of the system and the operating practices at this airport, we found that one of the 3 pumps was always on standby. The other 2 pumps came on stream alternately, depending upon demand. See Sketch No. 1. The problem was that the system designer had failed to install check valves in each filter line. When one or two pumps were operating, some flow was recirculating backward through the other pump and filter separator. This reverse flow caused the coalescer elements to fail.

The filter separator failed but the fault was obviously that of the system designer. For little more than \$100.00 per branch we solved the problem by adding a check feature to each slug valve. Any brand of slug valve can also be a check valve simply by adding the correct check pilot valves.

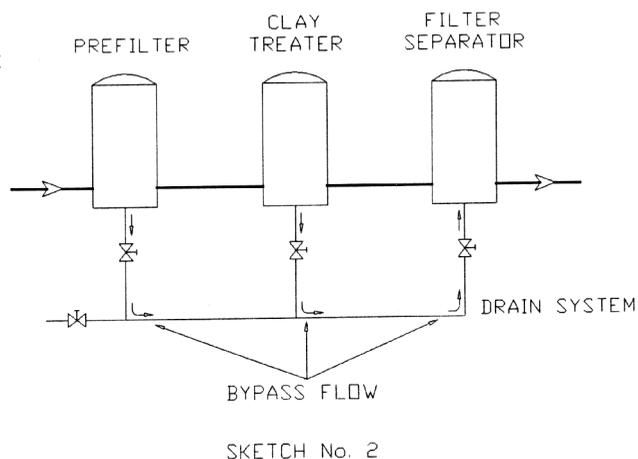
It took a while to find the answer. Look at the drain system in Sketch No. 2. Note that each vessel has its own drain valve but the designer added another shut off valve as a safety closure at the drain system outlet. We found each vessel drain valve open but the safety shutoff was closed. Here was the answer. Some of the flow that entered the prefilter went through the drain system carrying large particles into the filter separator. The reason the drain valves were left open was because the workmen found it awkward to crawl under the work platform to operate them. It was much easier to leave them all open and use the safety shut off valve when they performed their daily sump drains.
